# 2D Modeling of Big Bay Dam Failure in Mississippi: Comparison with Field Data and 1D Model Results

**ABSTRACT:** The failure of 17.4m-high Big Bay Dam in southern Mississippi, USA, on March 12, 2004, resulted in a catastrophic flood that damaged 104 homes or businesses, of which 48 were destroyed completely, 37 experienced major damage and the remaining 19 had only minor damage. Shortly after the failure, the USGS and USDA-NRCS jointly surveyed the high water marks and provided maximum elevation data at 42 locations along the entire length of the downstream valley. In addition, data is available on the types of damages sustained by various structures and roads in the inundated area. This data can, thus, be used for validation of 2D numerical models not only based on flow depth and flood arrival time, but also with regard to the failure criteria of structures; which is extremely important for consequence analysis in a risk-based study frame. This paper describes the simulation of the Big Bay Dam failure case using a 2D numerical model developed at the National Center for Computational Hydroscience and Engineering, the University of Mississippi. The numerical model solves full dyn

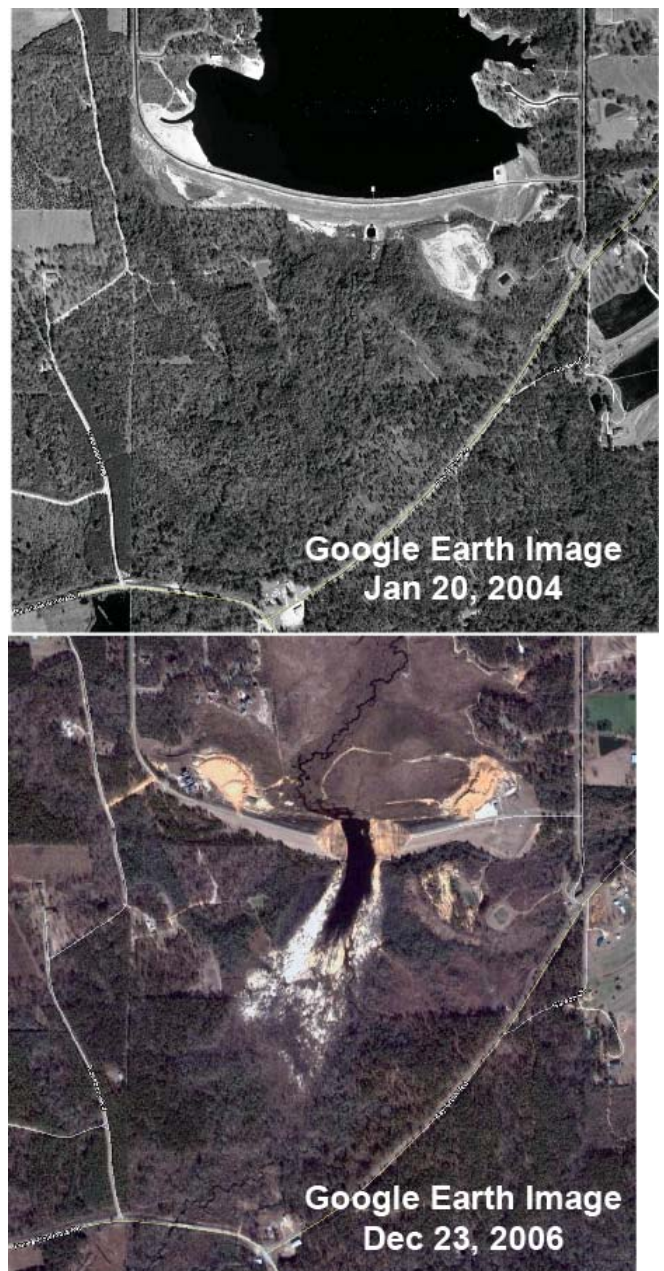
Figure 1. Satellite images of the Big Bay Dam before and after the failure. The scar left by the flood waters is clearly visible in the image below.

On March 12, 2004, at about 12:35, the 13 year-old Big Bay Dam failed due to piping. The breaching took place in the area surrounding the

spillway structure. Figure 1 shows the satellite images of the dam before and after the failure.
